Reconnaissance Inspection: Municipality of San Juan Municipal Separate Storm Sewer System (“MS4”) Permit (PRR040036)

PRASA Puerto Nuevo Wastewater Treatment Plant Collection System (PR0021555)

Inspection Date: February 16, 2012

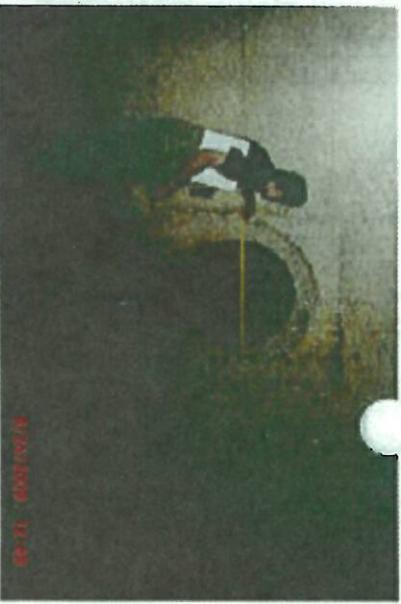
CIMG6446

EPA viewed Quebrada Juan Méndez from the South side of the Jesús T. Piñero Bridge, but could not see the outfall pipe below the bridge. However as described in the 2009 CSA Reports (See Attachment 3d) the discharge from a 30" circular sewer, was noted as possibly containing sanitary wastewater. Further review of this outfall to determine its current dry weather discharge status and any ongoing source(s) of dry weather flow.

SE DEBE VERIFICAR LAS DERRAMAS SABOREA DE SER ASI'
PERMUTAR TRABAJOS PARA SEPARAR SISTEMAS

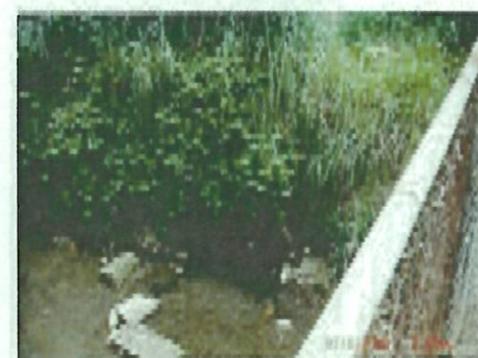
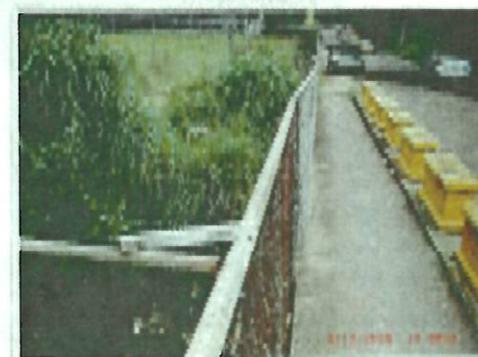
<input type="checkbox"/> In-Stream	(applicable when collecting samples)			
Flow Present?	<input checked="" type="checkbox"/> Yes <input type="checkbox"/> No	If No, Skip to Section 4		
Flow Description (If present)	<input checked="" type="checkbox"/> Trickle <input type="checkbox"/> Moderate <input type="checkbox"/> Substantial

Cleaning, uncover

VERIFICAR POSIBLE DESCARGA SANITARIA, DE SER ASI REQUIERE TRABAJOS

JALC SEPARAR SISTEMAS

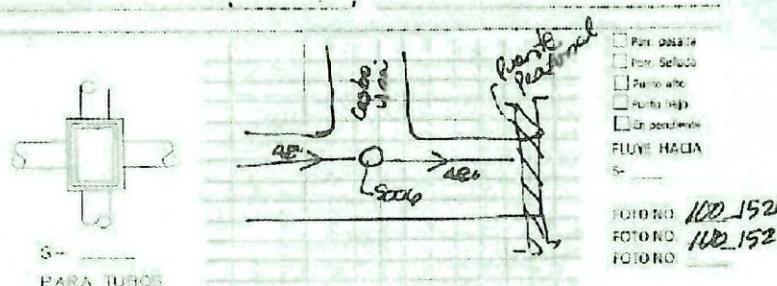
J6C

- Sistema contaminado.

*No problema de inundacion.
- reparar sistemas, contaminados. -*

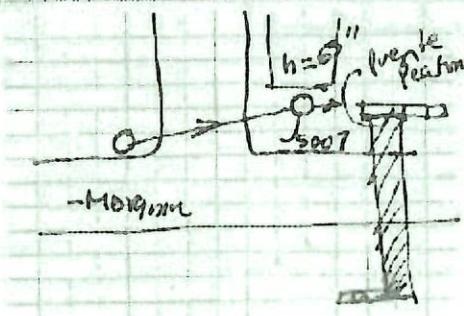
Manhole comburado... , h=63" hasta material de topo.

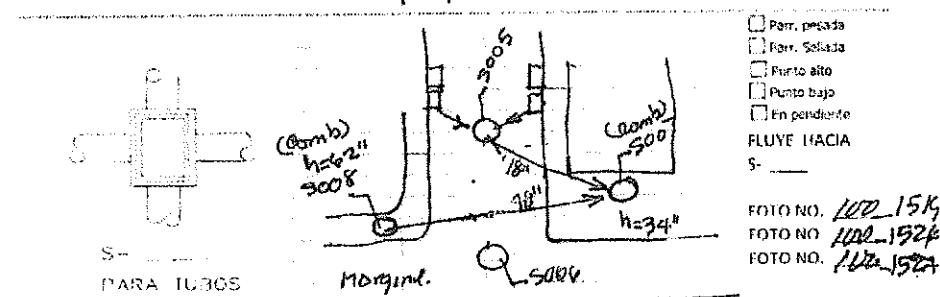
H4 parcialmente lleno de tierra. : h=34" hasta tierra.
-tubo de salida 18" y tapado.

PRIMERA VISITA LIMPIEZA, DESATAPAR

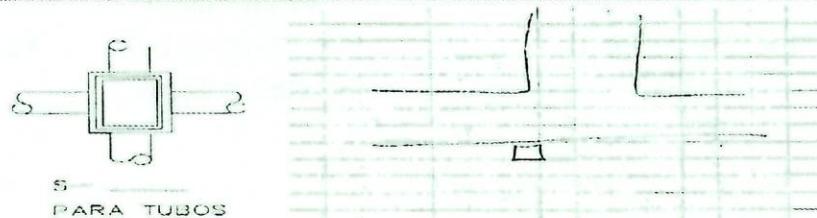
DESCRIPCION DEL PROBLEMA: PARRILLA DETERIORADA REPRESENTA UN PELIGRO PARA LOS VECINOS EN LA CALLEZA EN EL AREA DE LA ACERA Parce ester
en el callejón

- 1) Acción a largo plazo sacar esa estructura de ese lugar y relocalizarla.
- 2) Declaración de la autoridad que controla el

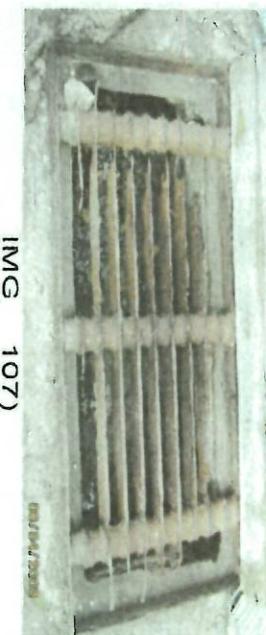
IMG 107

Estructuras sucias. La estructura K7aS-039A tiene la parilla deteriorada, puede estar combinado con el sanitario expide mal olor.
